Westover Village NC Plan - Street Condition Inventory

1000-1200 blocks North Jefferson Street, between Washington Blvd and Fairfax Drive.

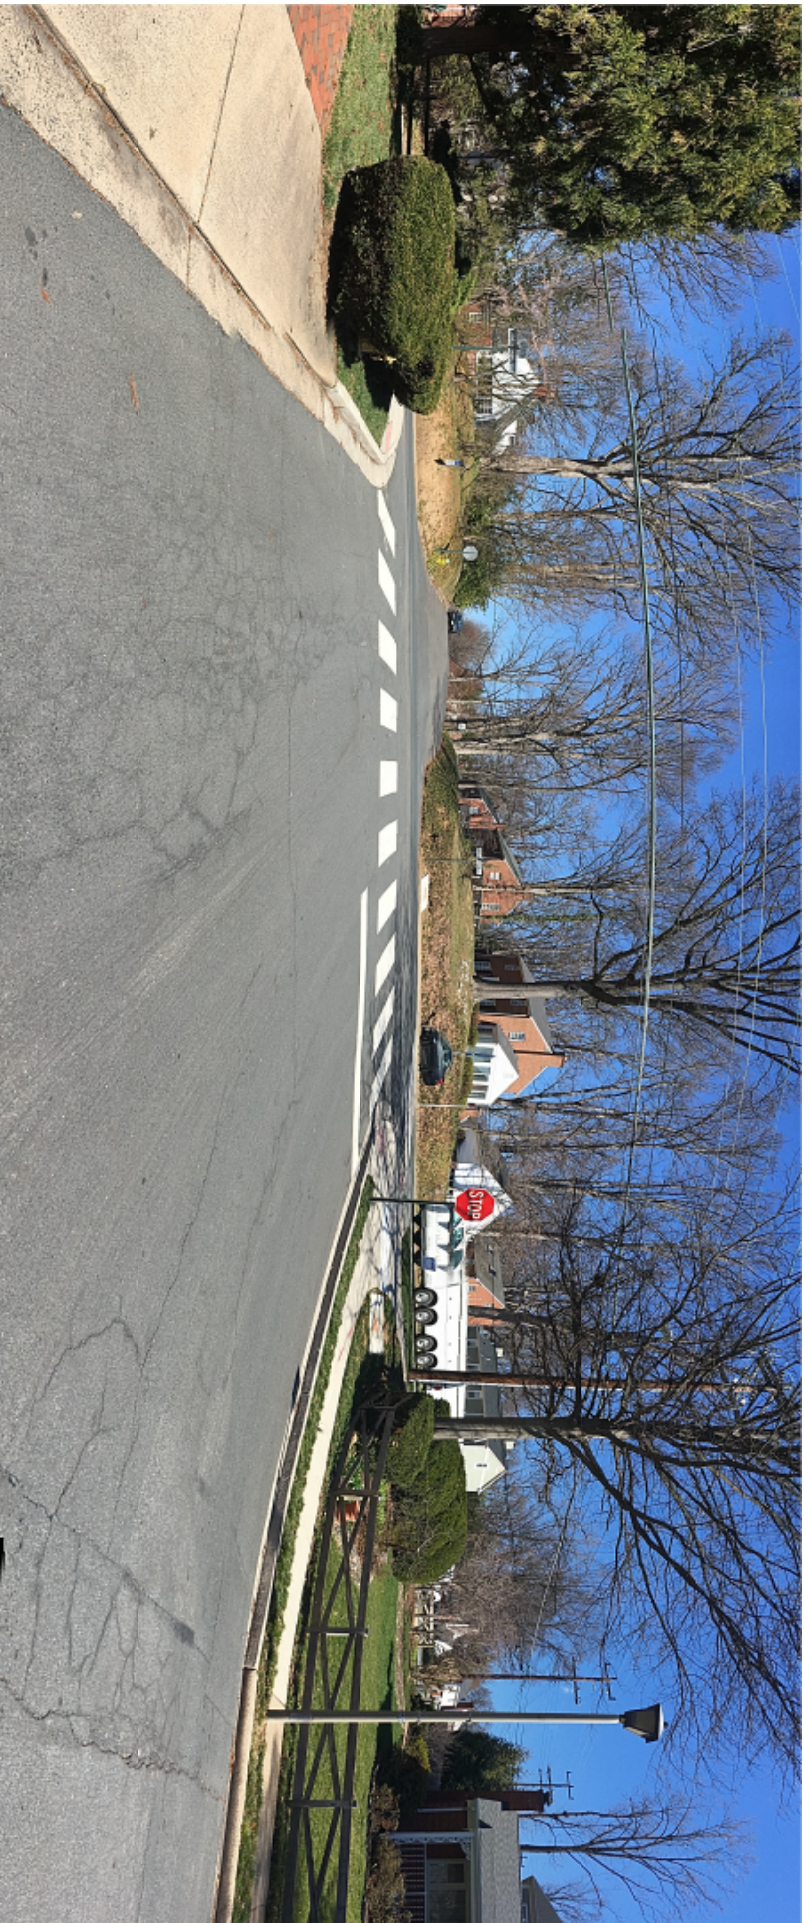
3.1 Washington Blvd & Jefferson St (cross) (image E)

8.3 Intersection at Washington Blvd and Jefferson St (image E)

8.2.1 Large bushes at SW corner combined with angle of street (uphill towards Washington Blvd), make visibility west difficult without pulling up into crosswalk

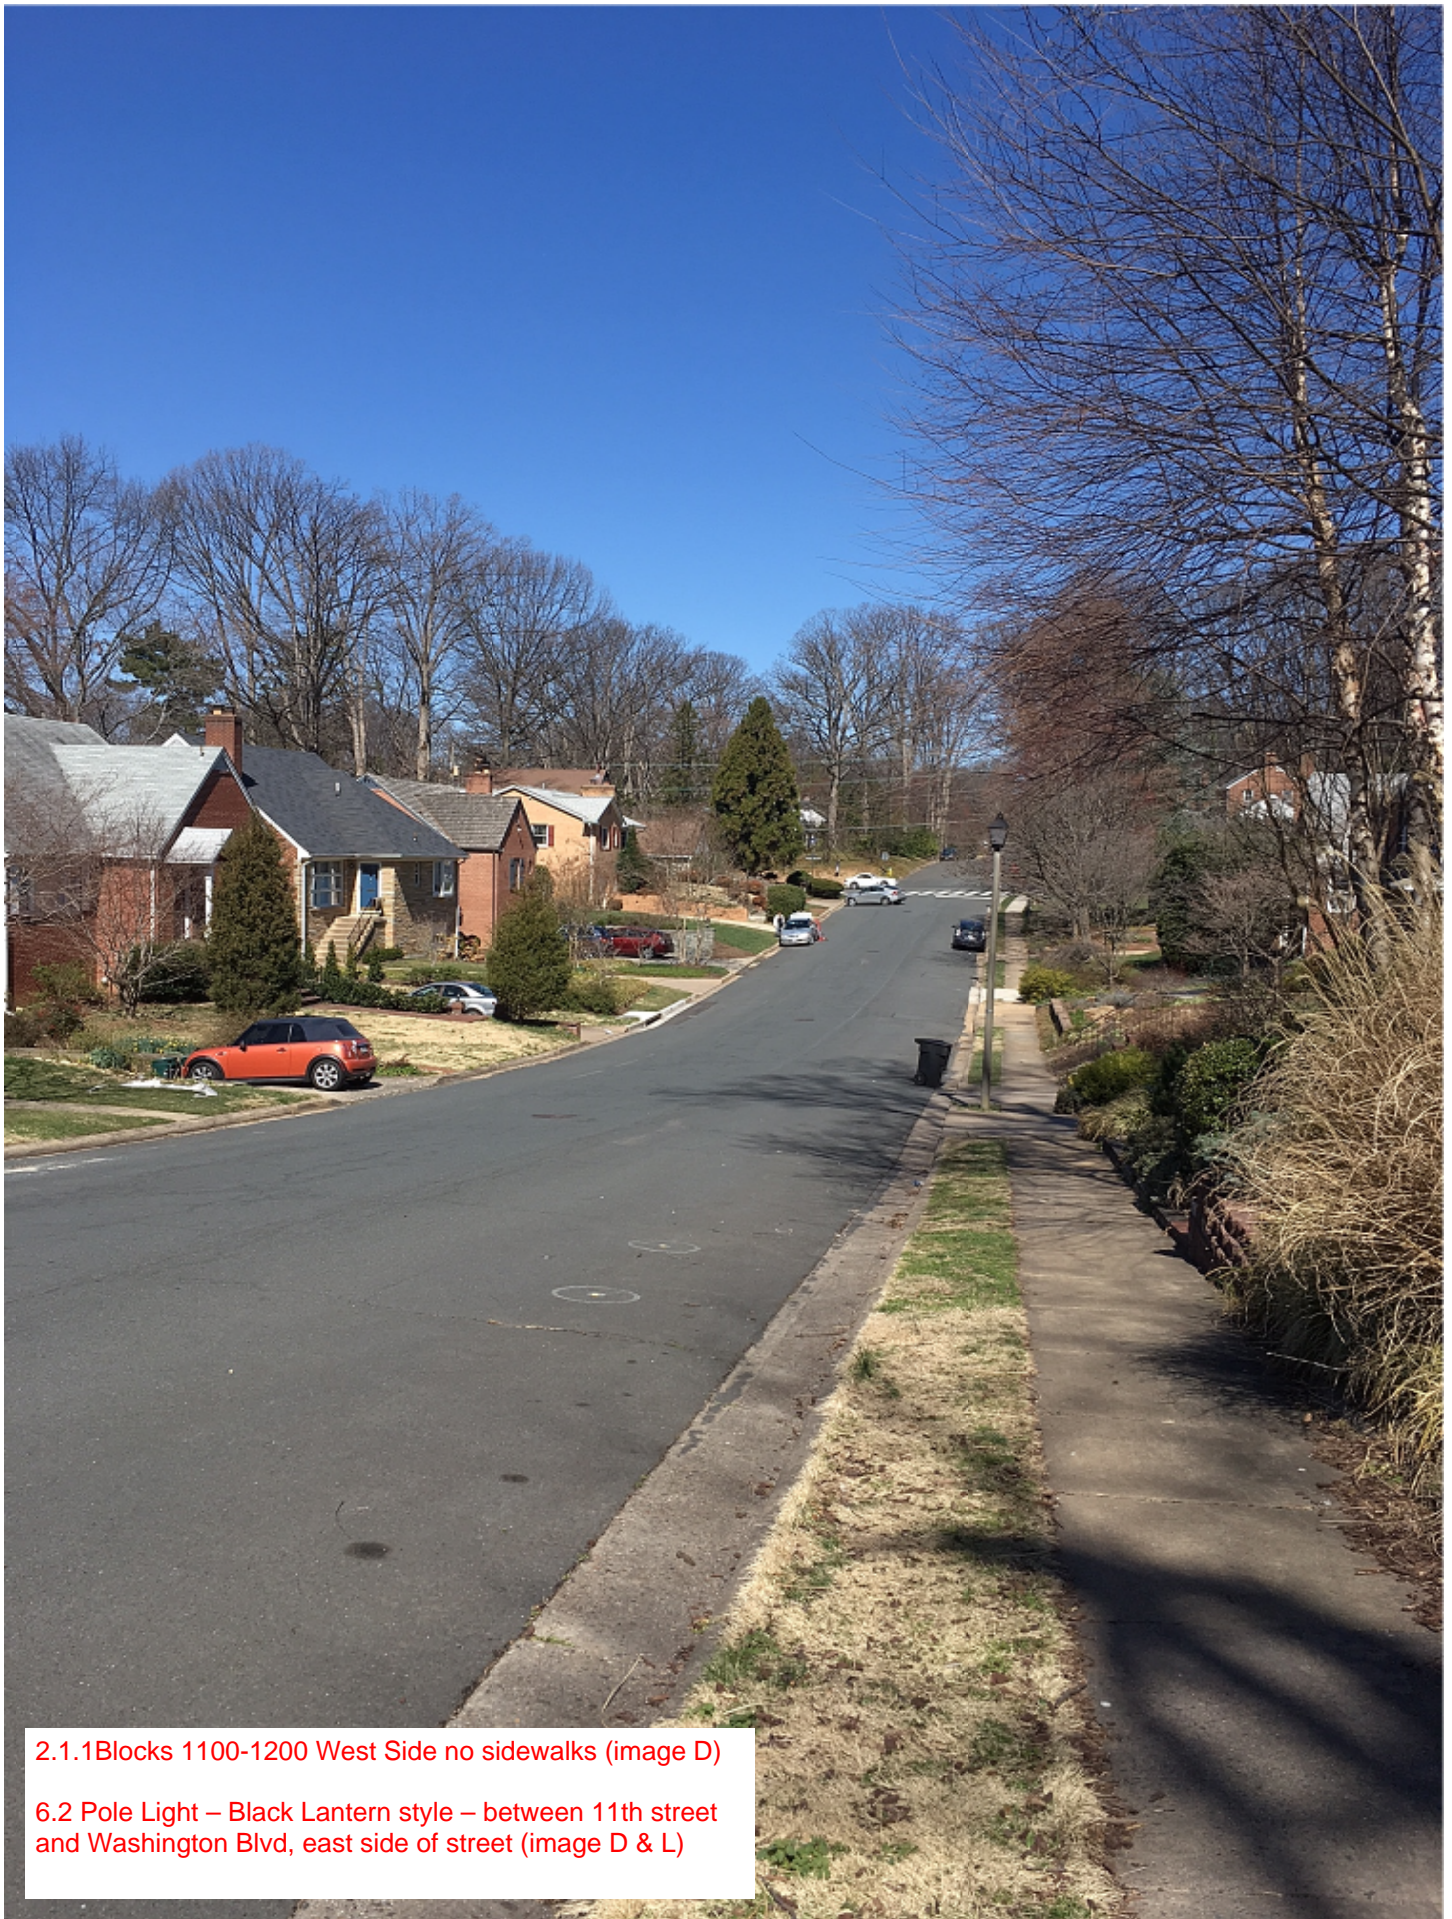
2.1.1 Blocks 1100-1200 West Side no sidewalks (image D)

6.2 Pole Light – Black Lantern style – between 11th street and Washington Blvd, east side of street (image D & L)

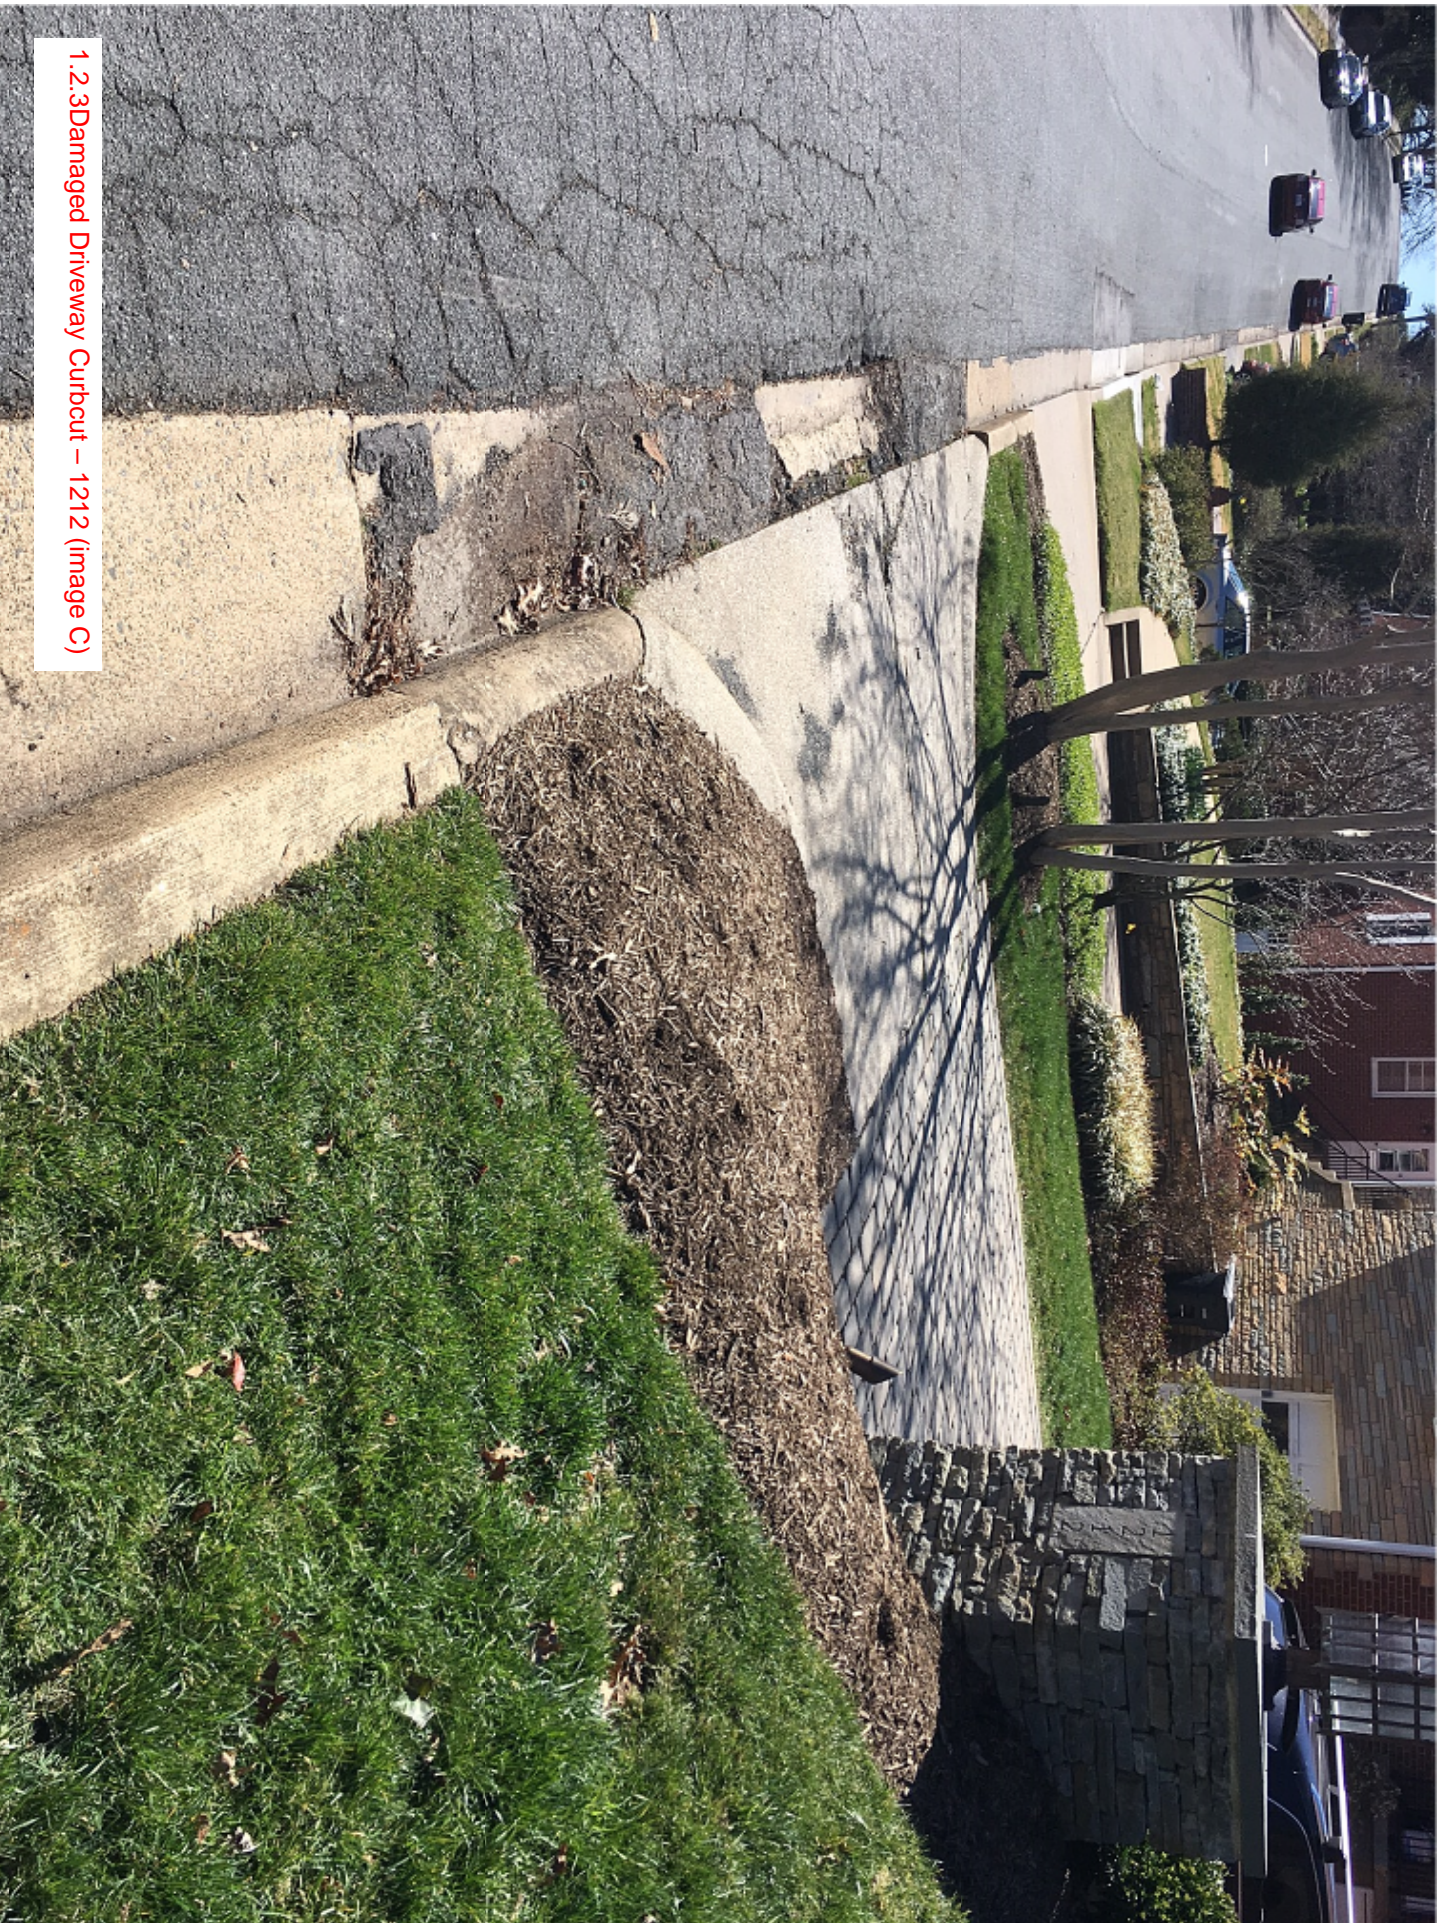
1.2.3 Damaged Driveway Curbside – 1212 (Image C)

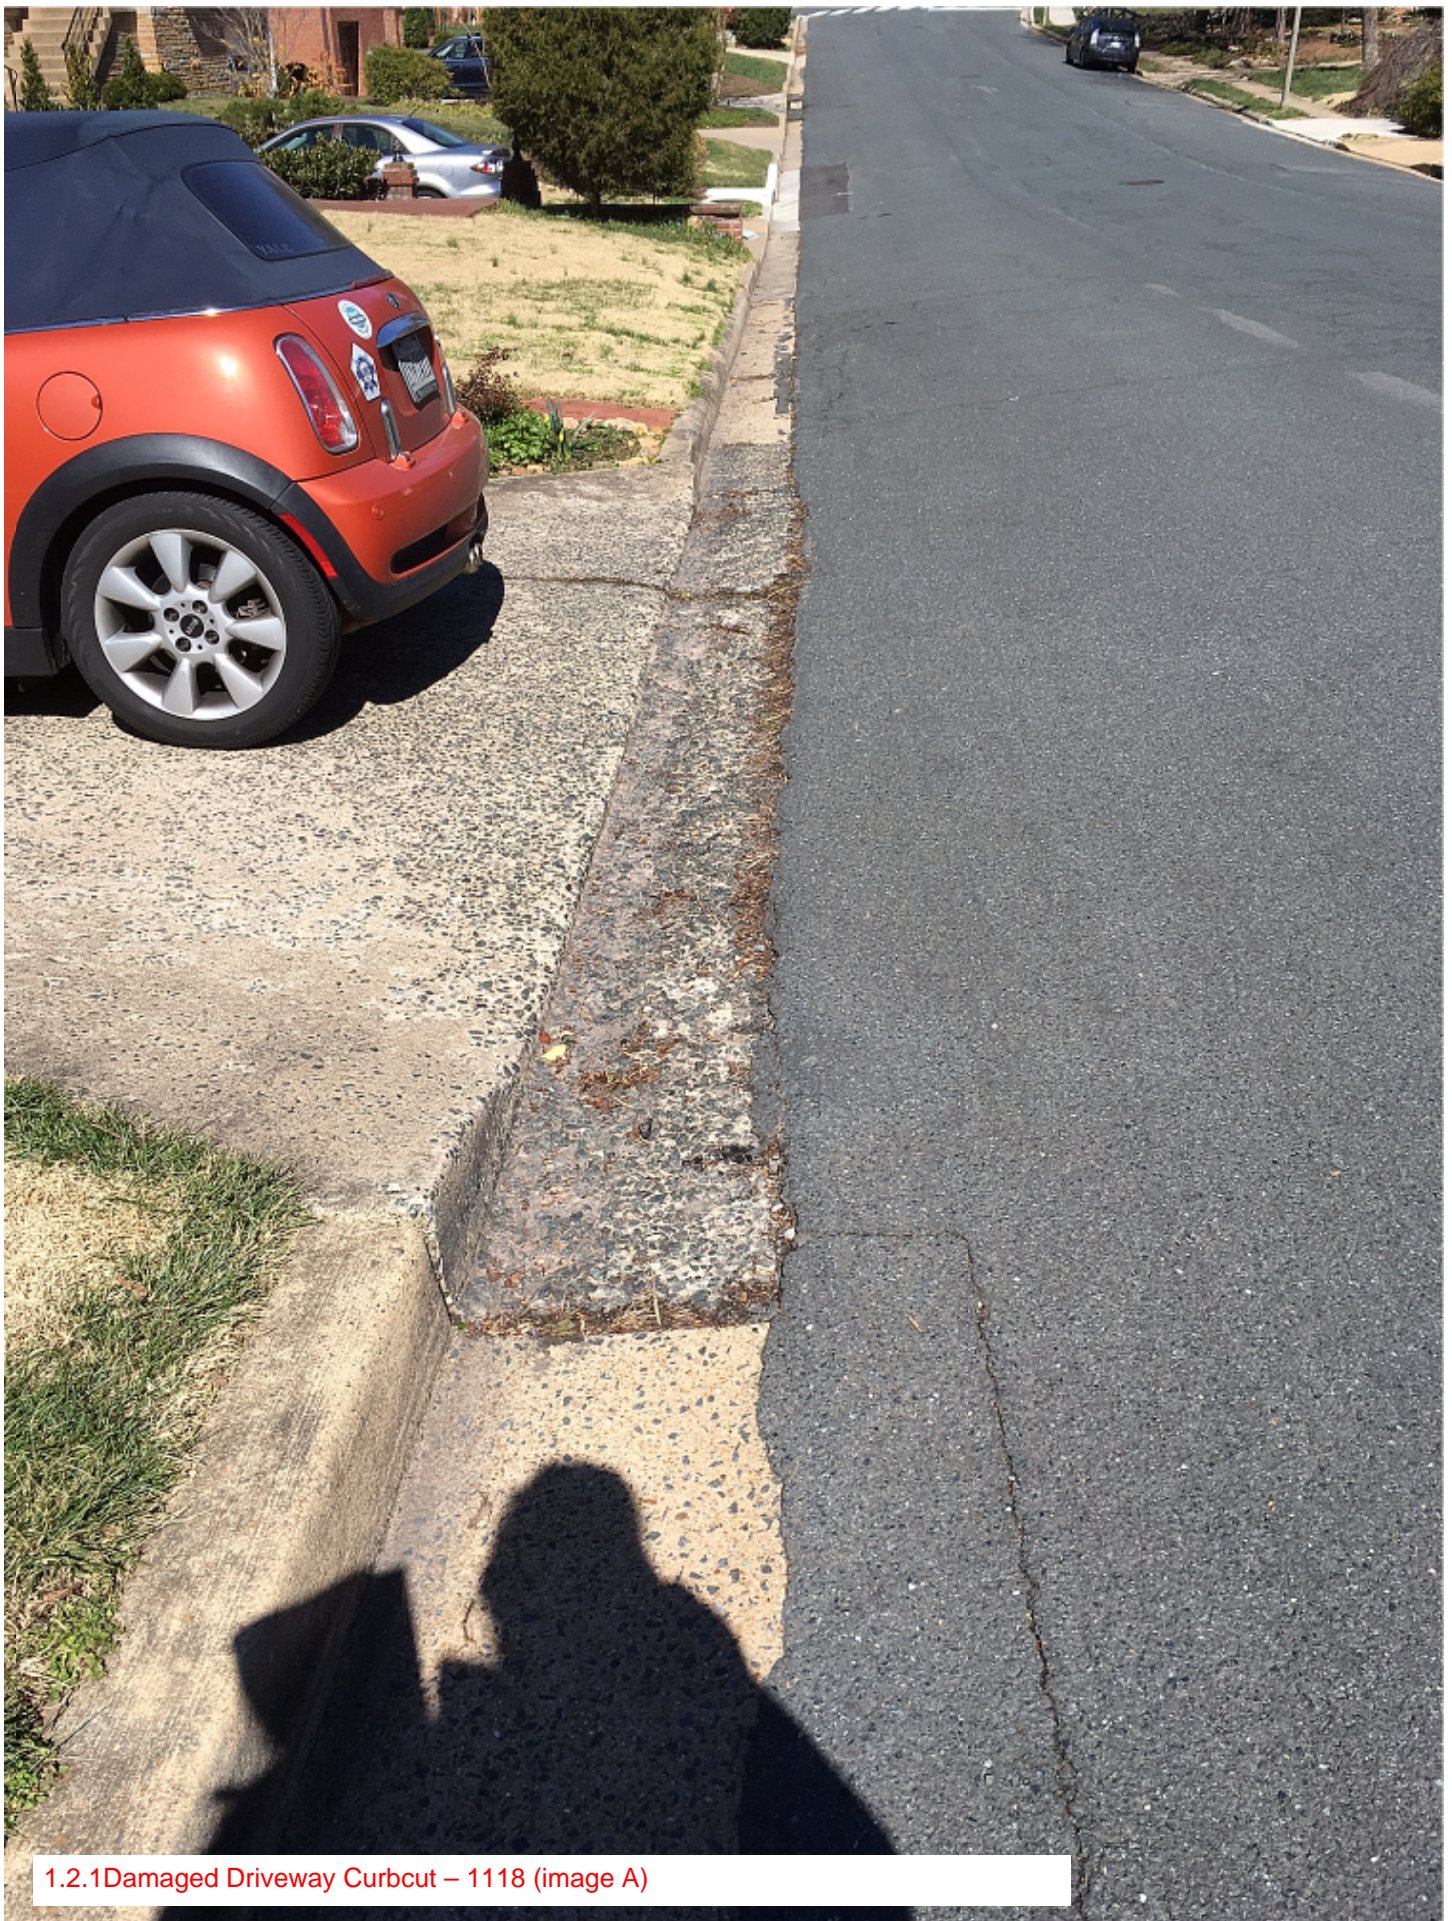
1.2.1 Damaged Driveway Curbcut – 1118 (image A)

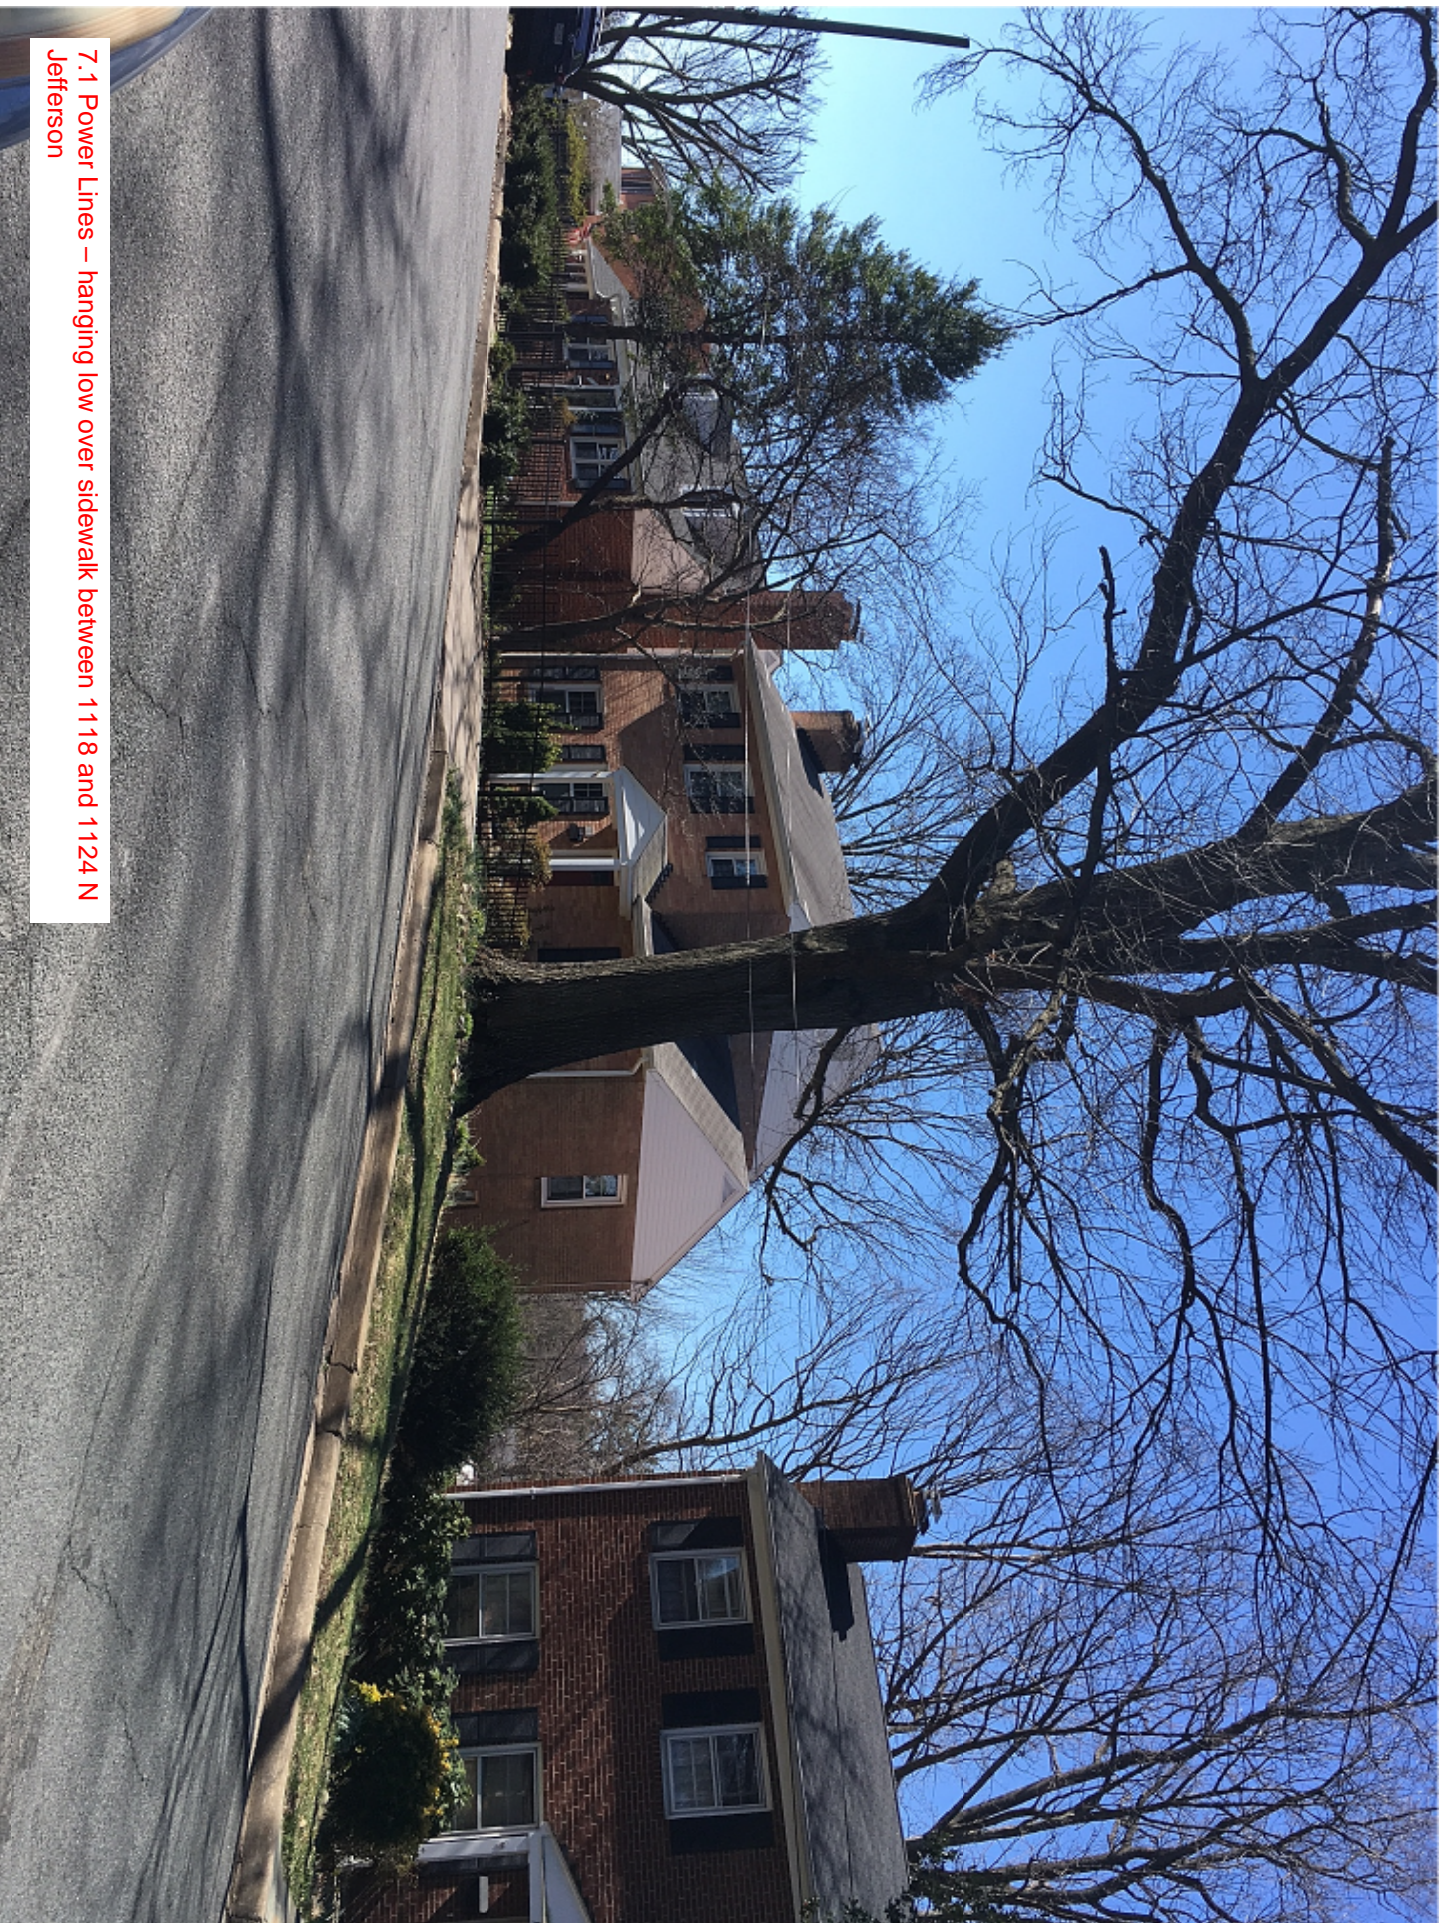
7.1 Power Lines – hanging low over sidewalk between 1118 and 1124 N Jefferson

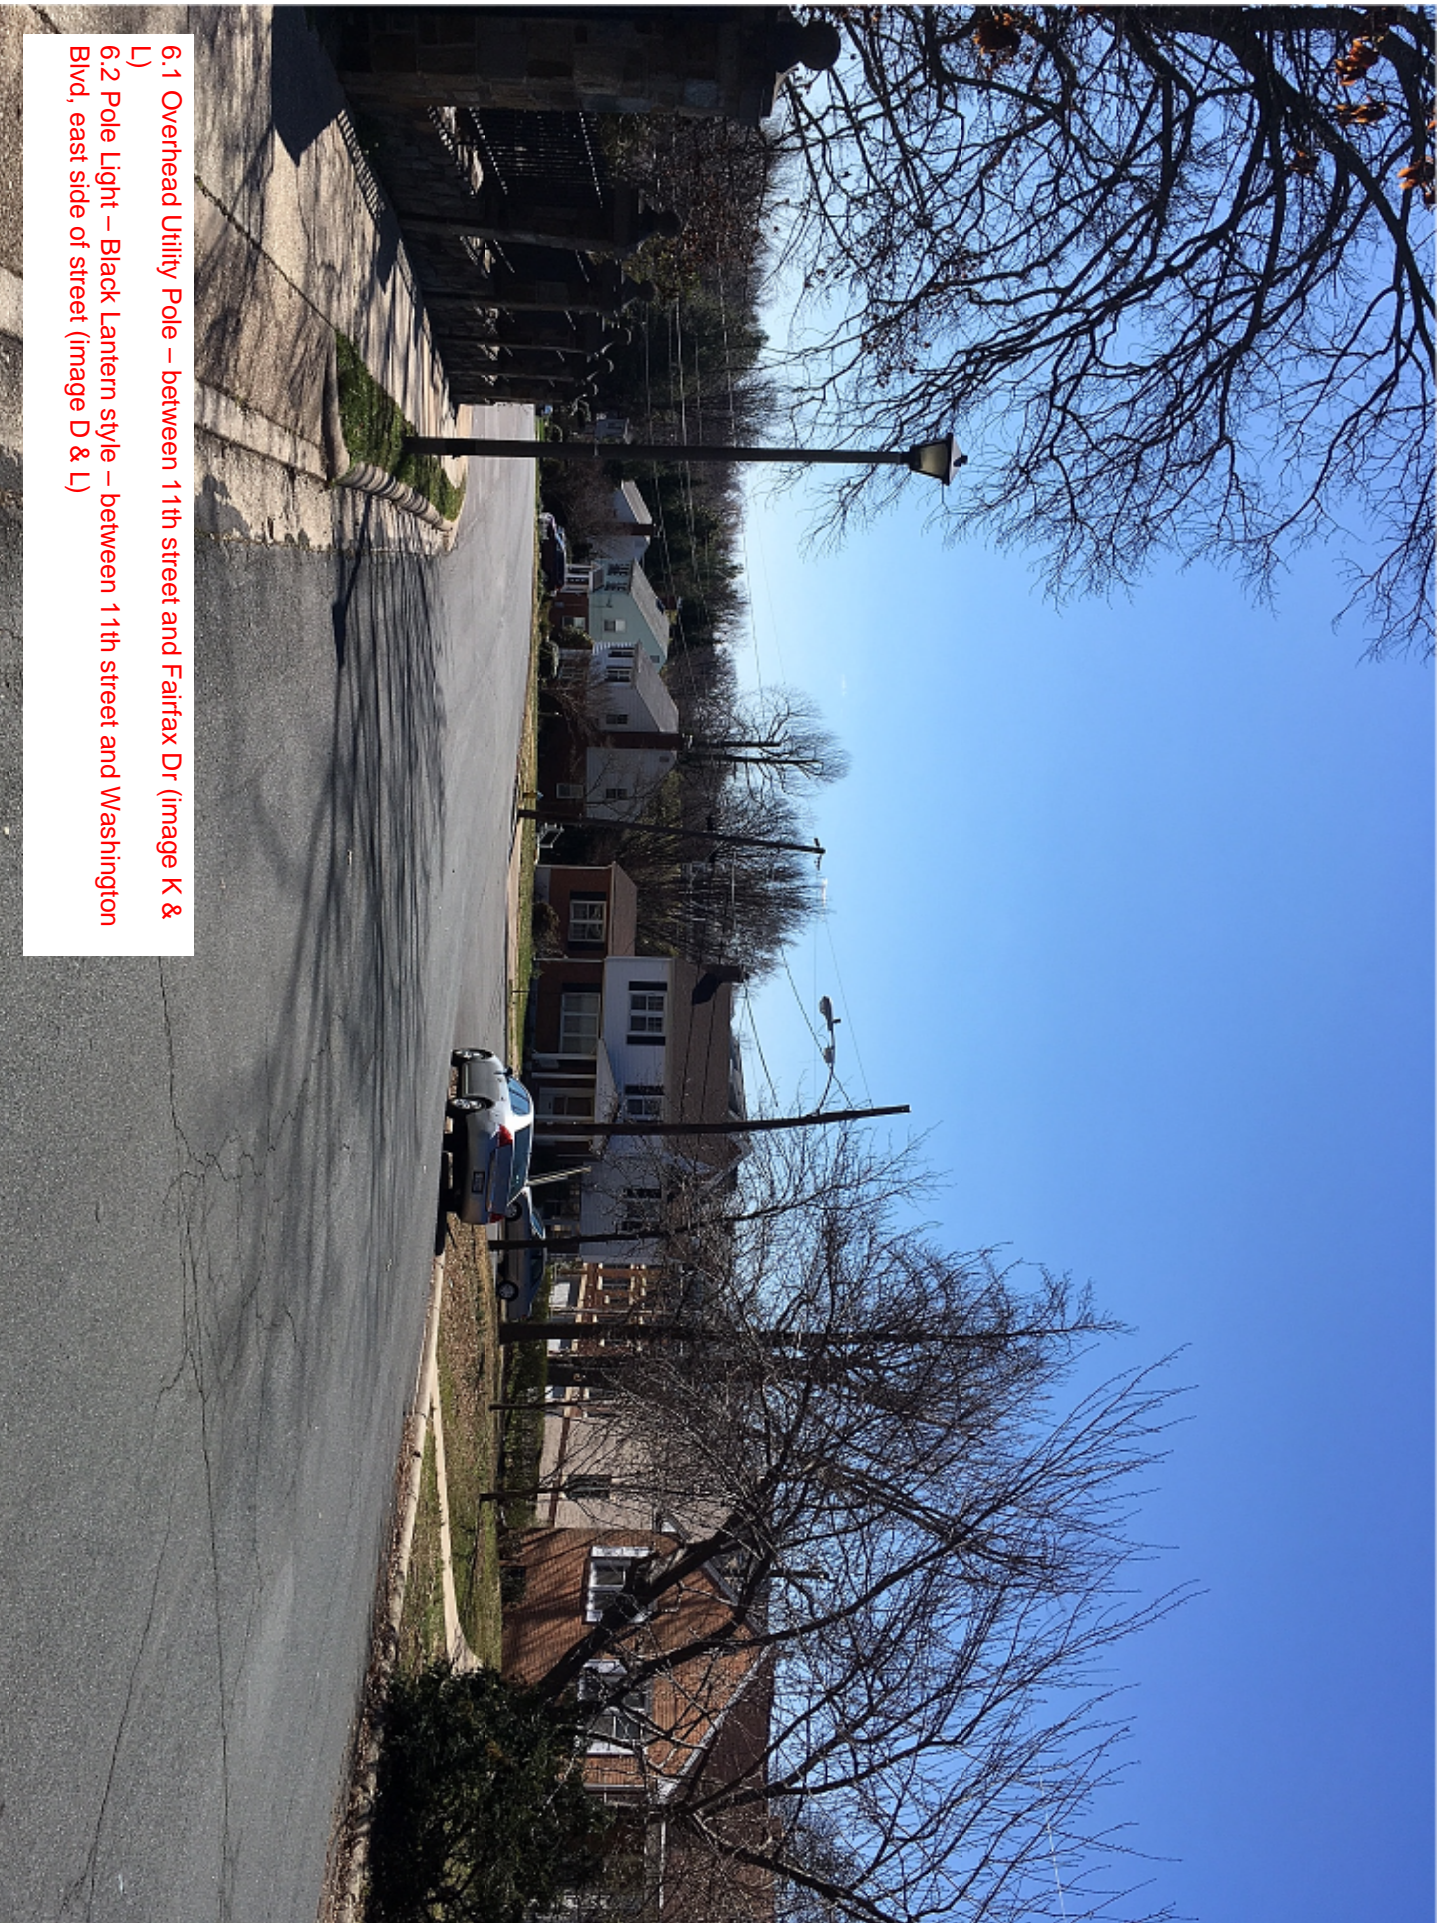
6.1 Overhead Utility Pole – between 11th street and Fairfax Dr (image K & L)

6.2 Pole Light – Black Lantern style – between 11th street and Washington Blvd, east side of street (image D & L)

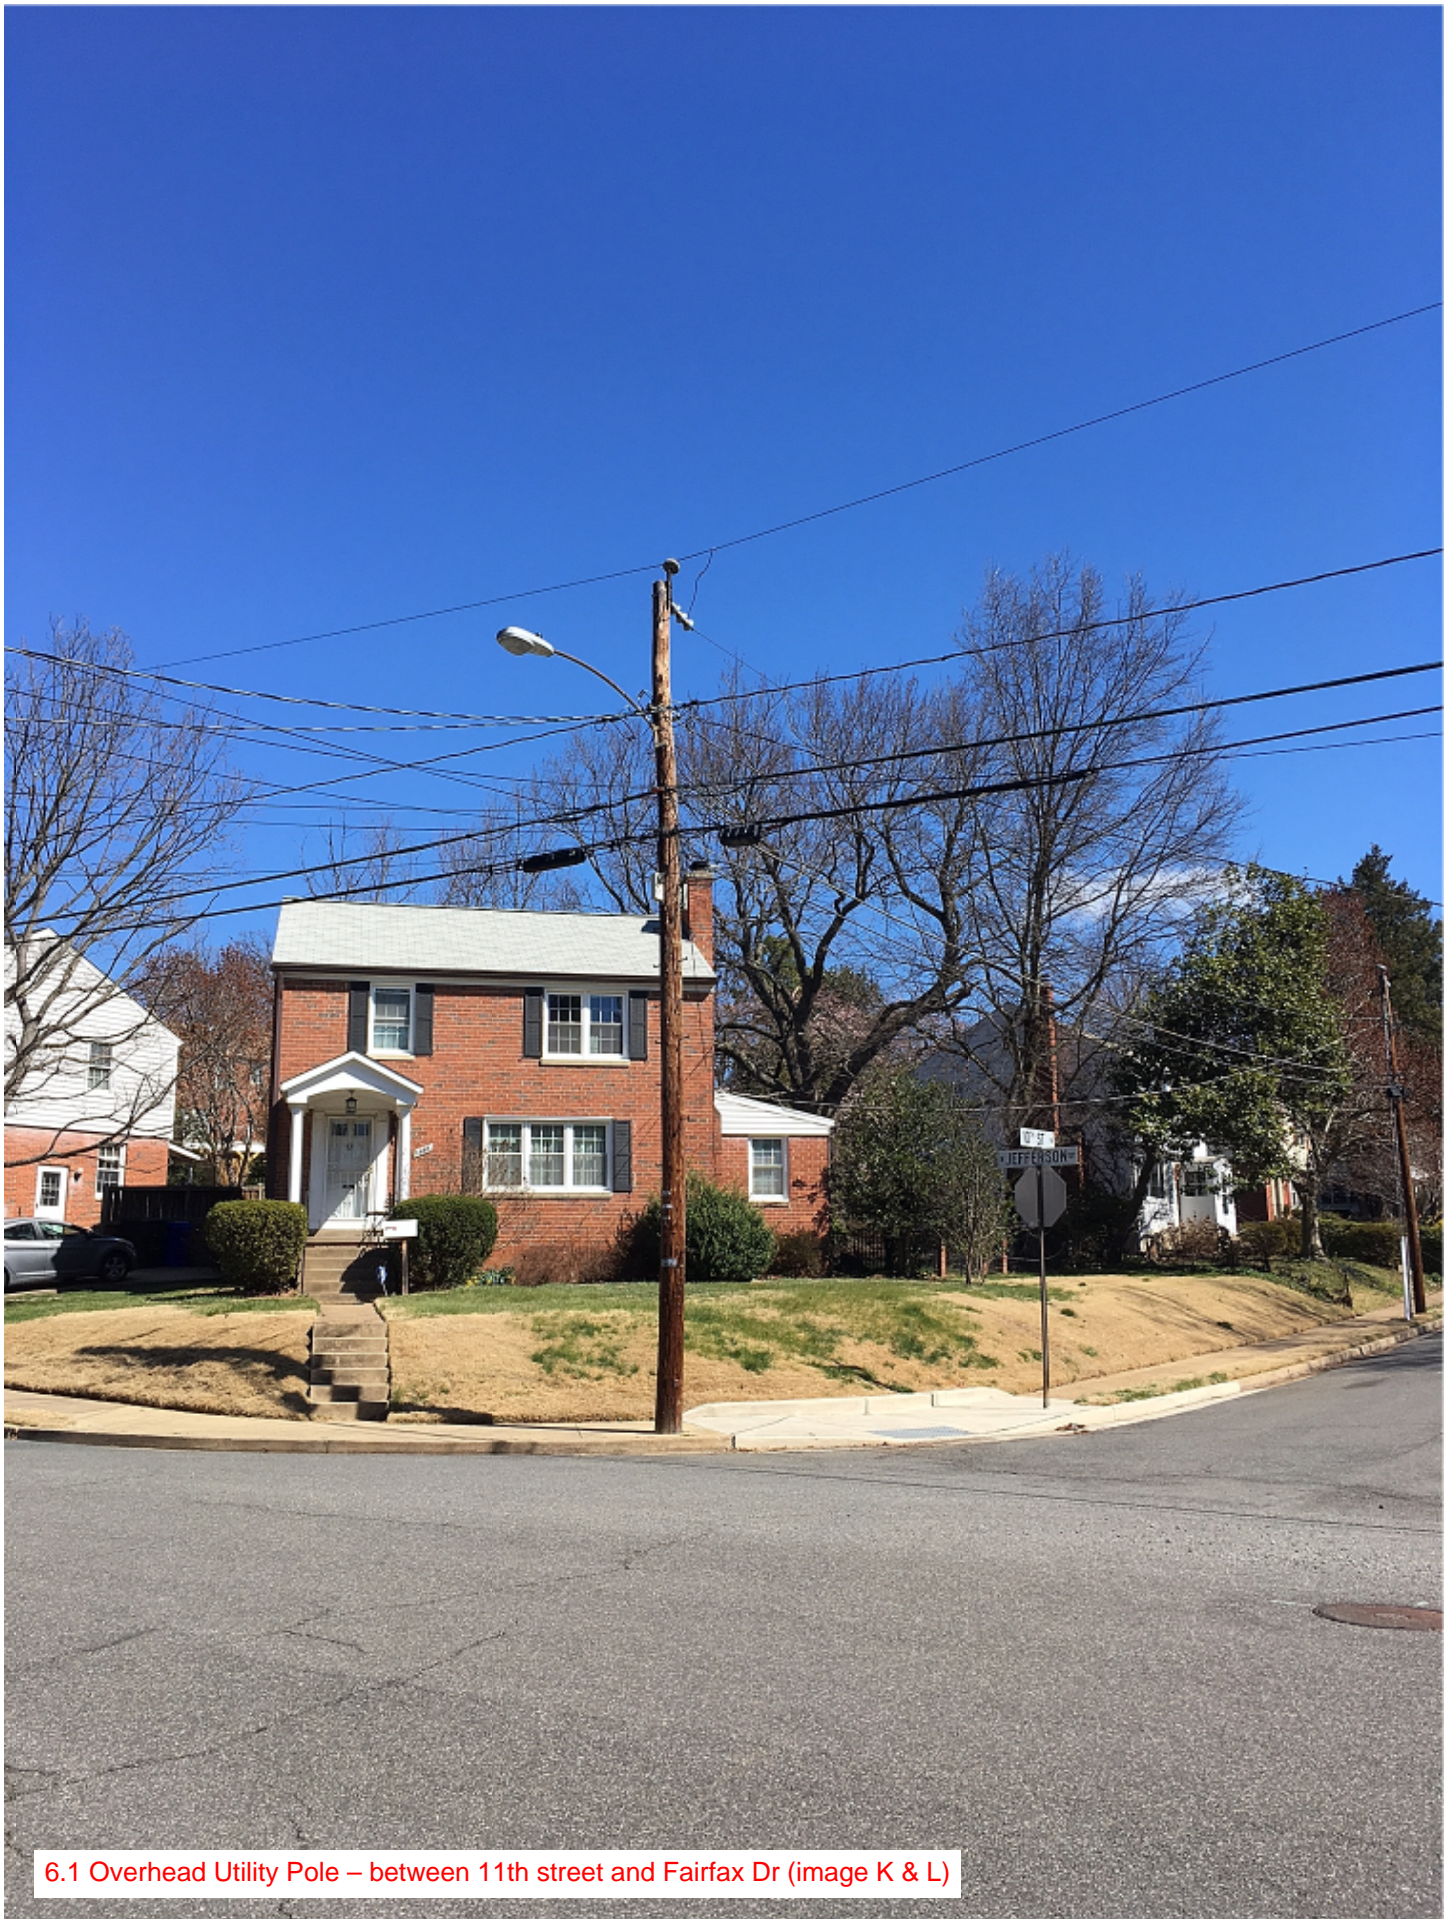
6.1 Overhead Utility Pole – between 11th street and Fairfax Dr (image K & L)

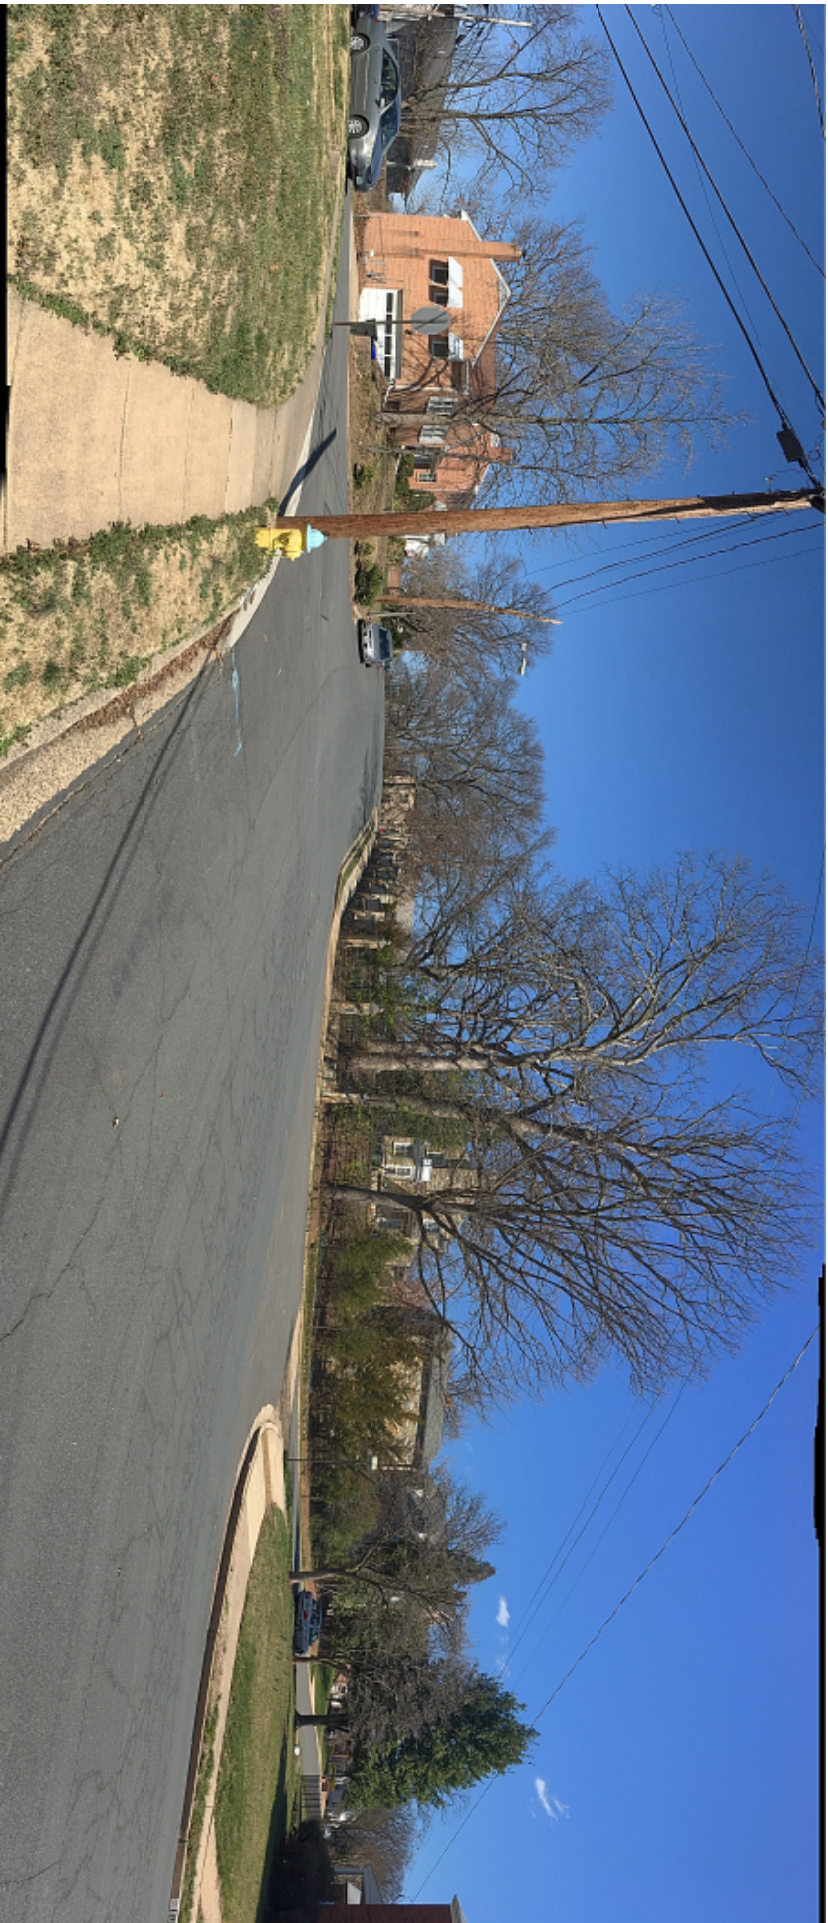
3.31 1th St & Jefferson St (cross) (image G)

- 3.3.1 Accessible Curb Cut – no curbcut @ NW corner due to no sidewalk
- 3.3.2 ADA Tactile Strip - none
- 3.3.3 Striping across street - none

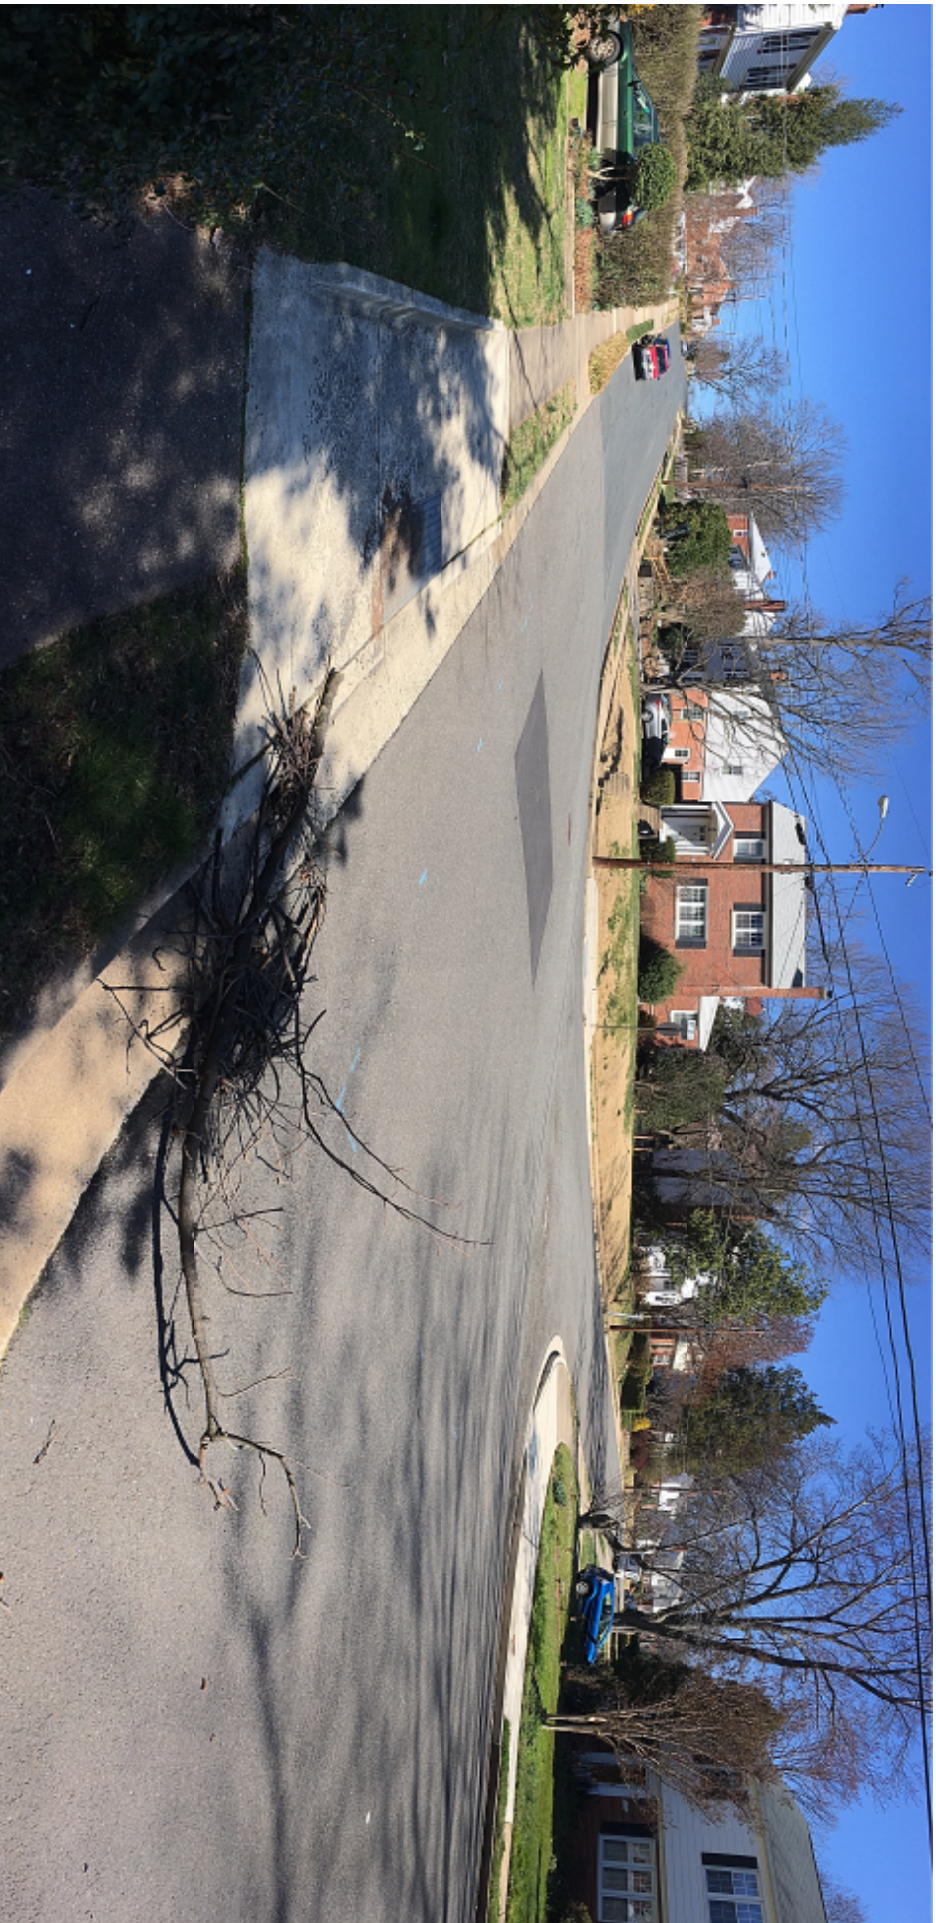
3.410th St & Jefferson St (t-from east) (image H)

- 3.4.1 Accessible Curb Cut – all corners and from west side of street
- 3.4.2 ADA Tactile Strip – all curb cuts
- 3.4.3 Striping across street - none

- 5.1.1 Low spot at tactile strip fills with water and debris
