Westover Village NC Plan - Street Condition Inventory

1000-1200 blocks North Jefferson Street, between Washington Blvd and Fairfax Drive.

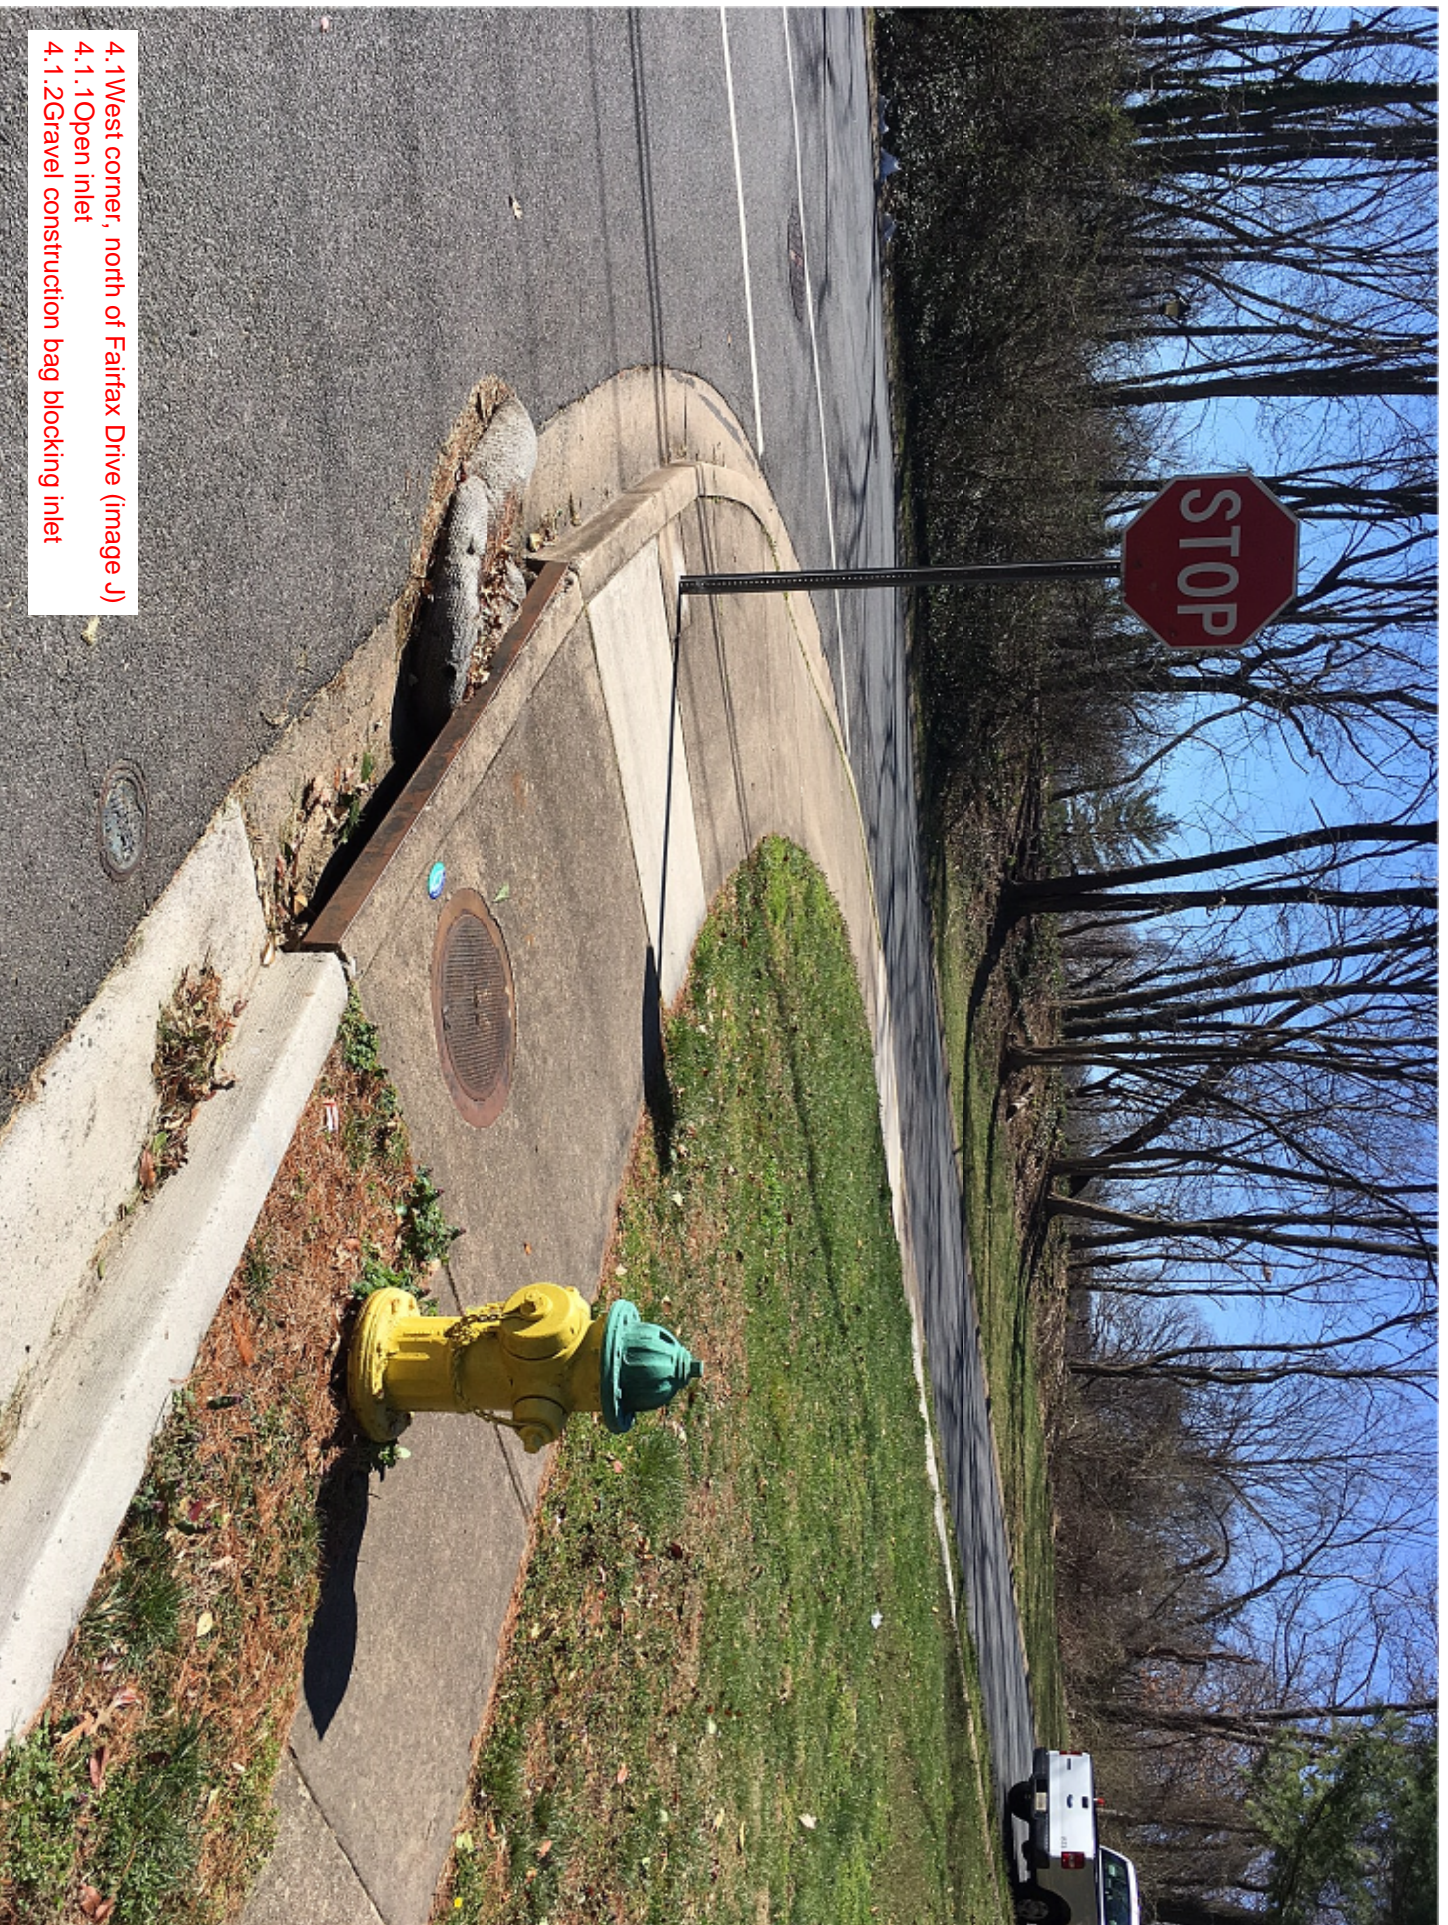
4.1 West corner, north of Fairfax Drive (image J)
4.1.1 Open inlet
4.1.2 Gravel construction bag blocking inlet

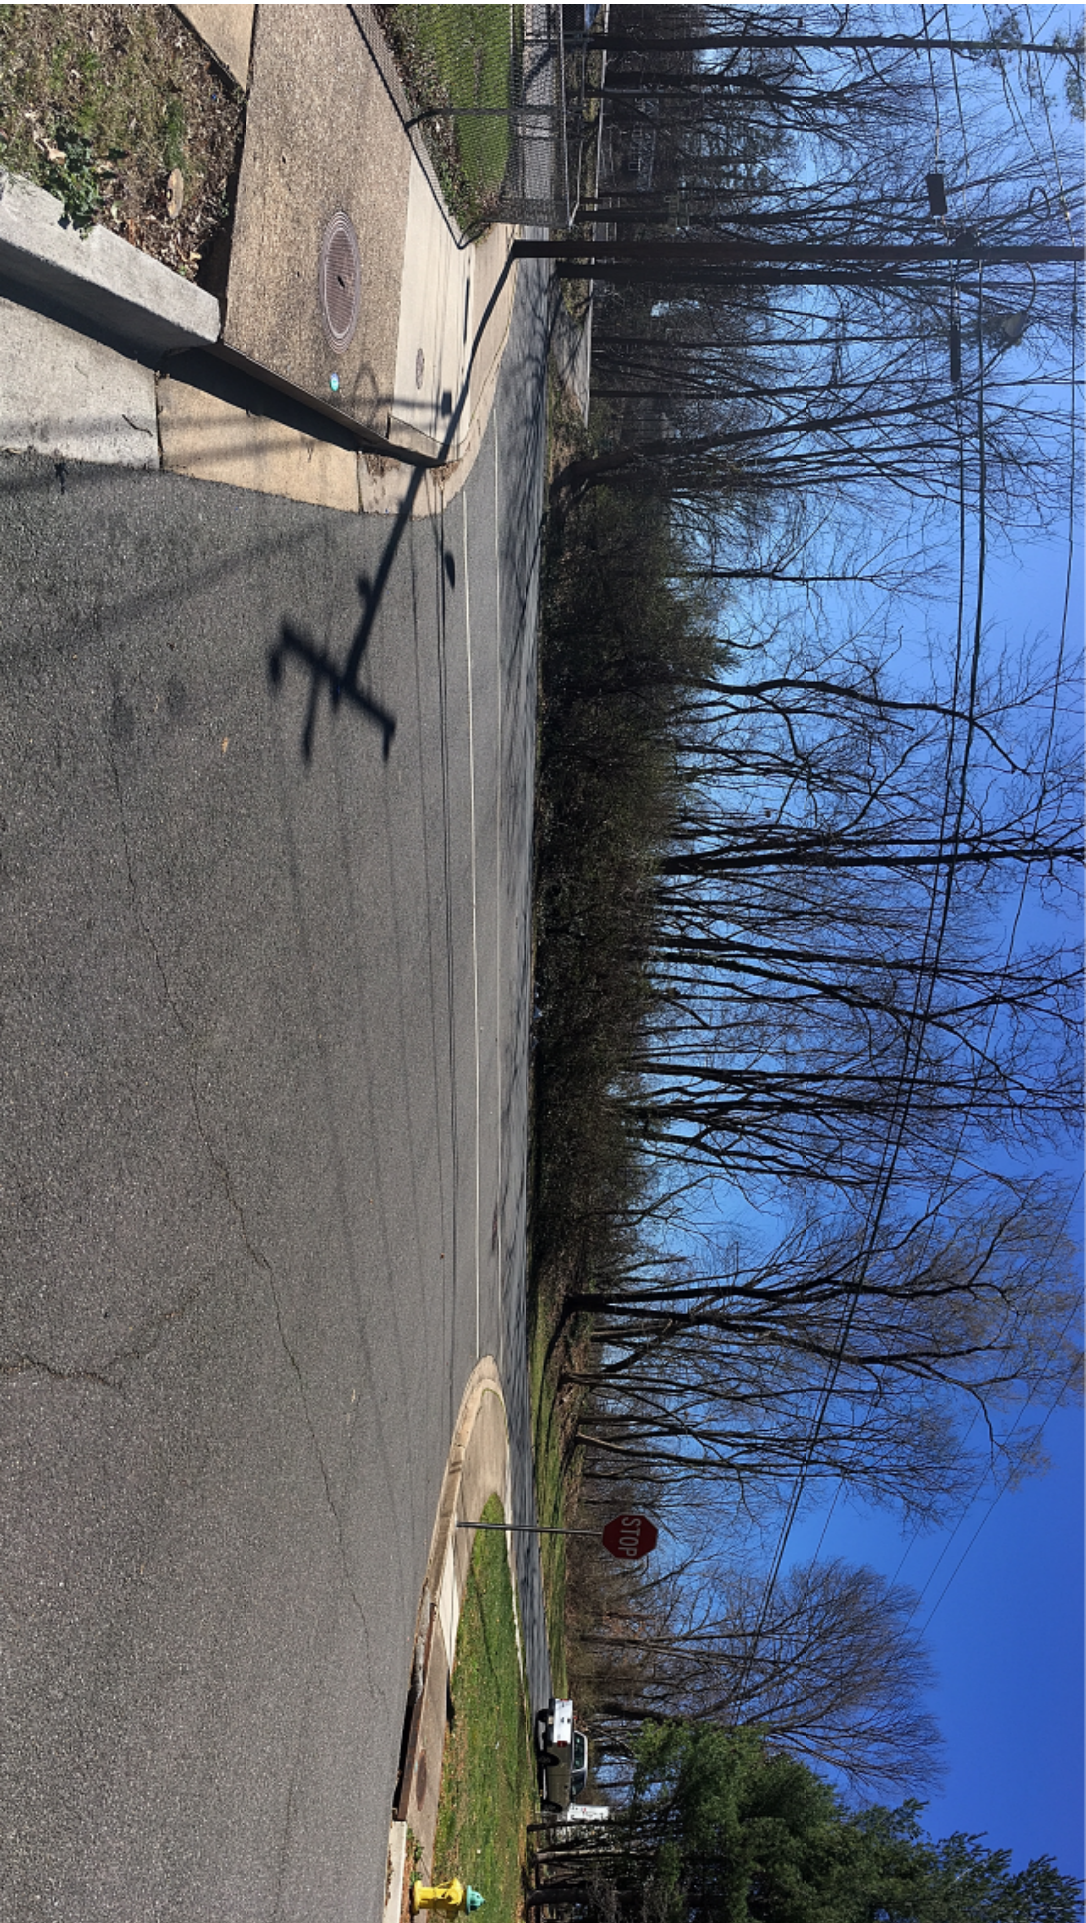
3.5 Fairfax Dr & Jefferson St (t-from north) (image 1)

- 3.5.1 Accessible Curb Cut – all corners, no curb cuts on south Fairfax due to no sidewalk
- 3.5.2 ADA Tactile Strip – all curb cuts
- 3.5.3 Striping across street - yes
